Phase I Inspection Report

Rainbow Lake Dam

Upper Hudson River Basin, Hamilton County, NY

Inventory No. NY 18

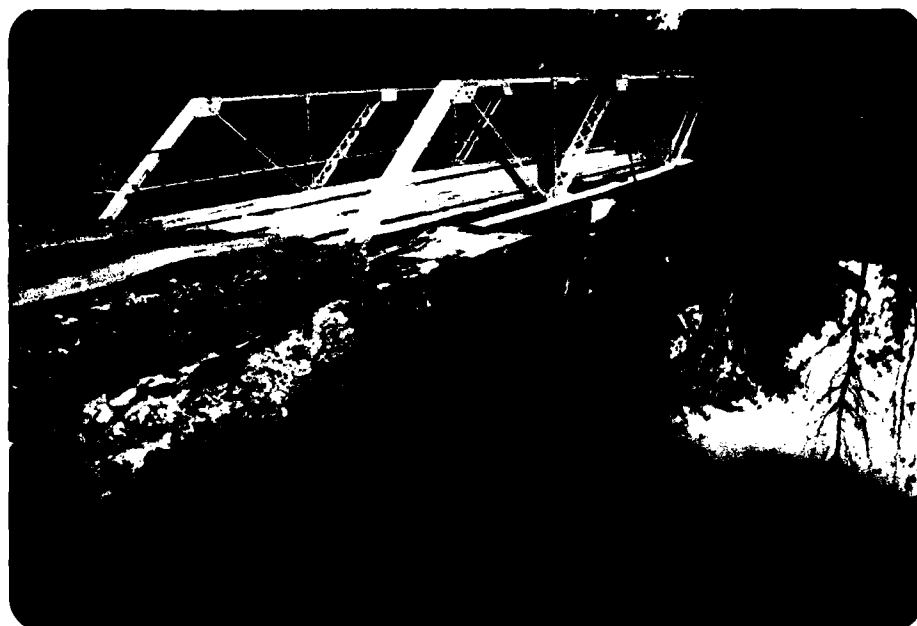
Upstream Face - Note Void to Left of Spillway

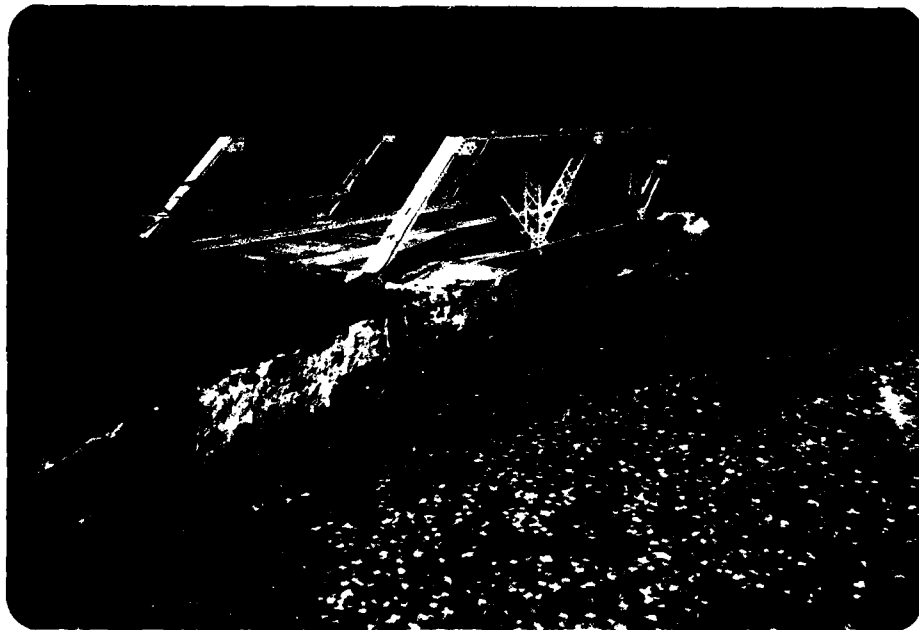
Dam and Spillway As It Appeared on 10/4/79 With Some Flashboards in Place
